Preservation Tech Notes

WINDOWS NUMBER 22

Maintenance and Repair of Historic Aluminum Windows

Kaaren R. Staveteig
Technical Preservation Services
National Park Service

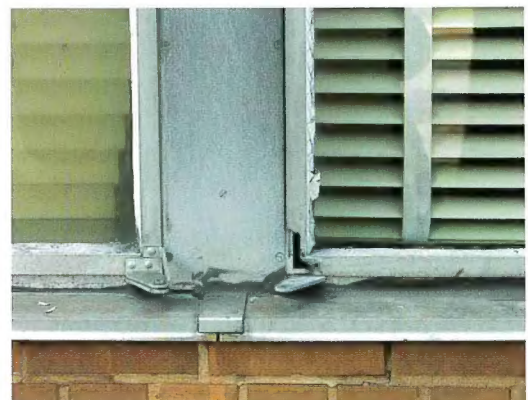
Figure 6. Deferred maintenance can result in a series of problems, such as broken hardware, cracked or missing glazing putty, and missing perimeter caulk (all shown above). All of these problems can be corrected. Note the uneven nature of the surface deposits of pollutants and grime on the mullion and sill of this window due to weathering and lack of cyclical cleaning.

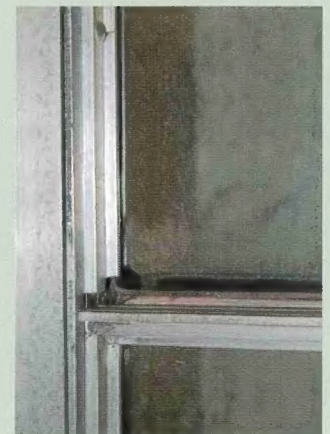
A window survey was first undertaken to record the condition of each window and to inventory the hardware, fasteners, and missing frame pieces. Although the windows retained a high degree of historic integrity, some changes had been made over the years. To allow for the installation of ventilation louvers or window-mounted air conditioning units, over 400 of the hoppers below the casements had either been removed or had been rendered inoperable and the wide vertical muntin removed. Although the historic windows were not designed for weatherstripping, some of the windows had been retrofitted with weatherstripping to reduce air infiltration as a result of worn hardware or deflections in the operable units. At various times, caulk had been applied to set in replacement glass or to fill in unwanted gaps. Areas of surface deterioration were also evident including discoloration and varying degrees of corrosion and pitting.

Figure b. The panes of glass were secured into the frame with aluminum glazing stops, each individually cut, drilled, and fixed in place from the inside. Here the vertical stop is in place while the horizontal is missing.

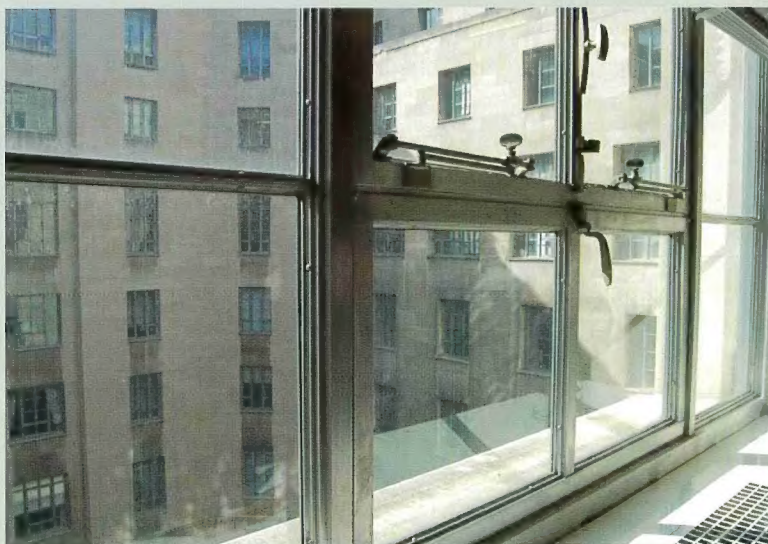
Figure c. In cleaning historic aluminum windows, the gentlest means possible should be used. More aggressive cleaners should be used only where necessary. The interior surface of this window was cleaned ten years ago with an aluminum jelly cleaner, rinsed and then dried thoroughly. The original mill finish still retains its luster.

needed. The aluminum was then rinsed to remove the cleaner residue (Figure c). For the exterior surfaces of windows that were more heavily corroded, the aluminum restoration company proposed a more aggressive chemical cleaner be used. This necessitated that the surrounding limestone surfaces around each window be well protected. During a mockup cleaning exercise, this chemical cleaner proved too acidic, difficult to control, and damaging to the adjacent stone. After testing some alternate products, the team found that a diamond abrasive pad used in combination with the Duro Aluminum Cleaner in jell form, worked the best. Special care was still necessary to protect the surrounding limestone.

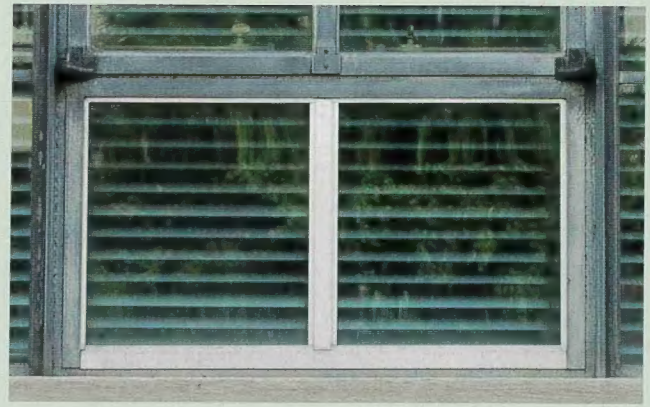
Figure d. Numerous hopper units have been removed over time to accommodate air conditioning units. Replacement hopper units were manufactured, as needed, to match the original hoppers elsewhere in the building.

An aluminum company reproduced the vertical muntin that historically existed in the hopper unit but was missing from numerous units. After the muntins were cut to size, each was slotted at the end and fitted into the hopper frame, and then welded at the tip. The same company also made custom extrusions for the rails and stiles of the hopper units for use in fabricating entire hoppers where missing (Figure d).

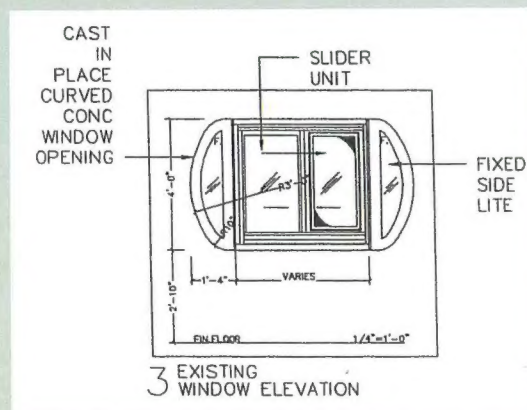
Figure b

Nearly all of the original windows had survived 40 years of Chicago's harsh winters and numerous abuses from high-density occupation. The architect completed a condition survey of 120 typical windows and found that 61% of the windows lacked the original glazing (replaced with Plexiglas or similar material), 31% had damaged operating sash, 29% were boarded up with damage to the frame, 25% were missing their original operating glazing sash, and 71% were missing screens. Only 15% of the windows had no visible defects.

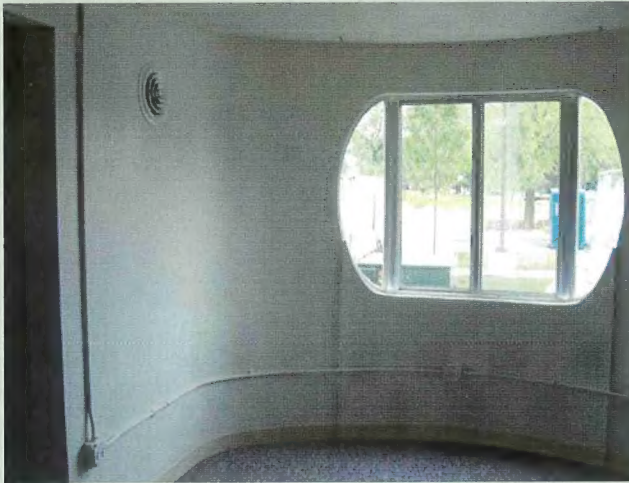
Figure e. Both interior and exterior aluminum surfaces had become dull, soiled, and oxidized as a result of traffic exhaust and air pollution. Cleaning the aluminum stabilized any further deterioration and brought back the luster of the original mill finish. (Photo: Holsten Real Estate Development Corp.)

The aluminum surfaces needed to be cleaned and taken back closer to their original appearance. Because of the effect of weathering and use, it was considered acceptable in this project to use certain cleaning techniques not normally recommended for more ornamental architectural aluminum. A common chemical cleaner and/or

denatured alcohol were used to remove the general residue on the aluminum. Wearing rubber gloves, the crew wiped on the cleaner with a damp cloth, allowed it to stand for 3-5 minutes, and then wiped it off with a clean damp cloth. Scouring pads and scrapers were sometimes used on more encrusted areas, as needed. The removable sash units were cleaned in the basement shop, while any frames that remained in situ were cleaned in place (Figure e).

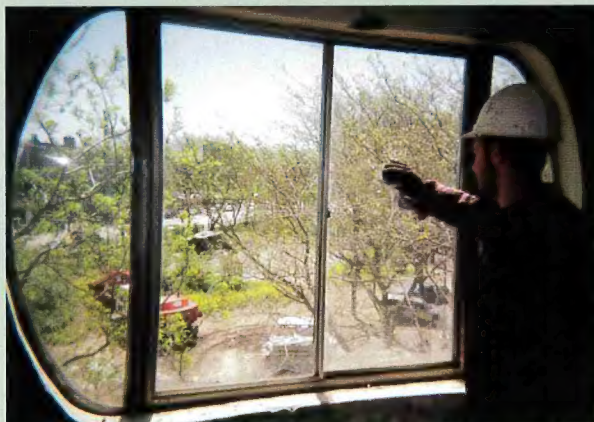
Figure f. Repair and replacement work was done from the inside to lessen the risk of damage to the outside finish. (Photo: Holsten Real Estate Development Corp.)
